The Department of Environment Protection and Energy Maanshan Iron & Steel Co. Ltd

2022 47

2022 4 A#
2#3#4#

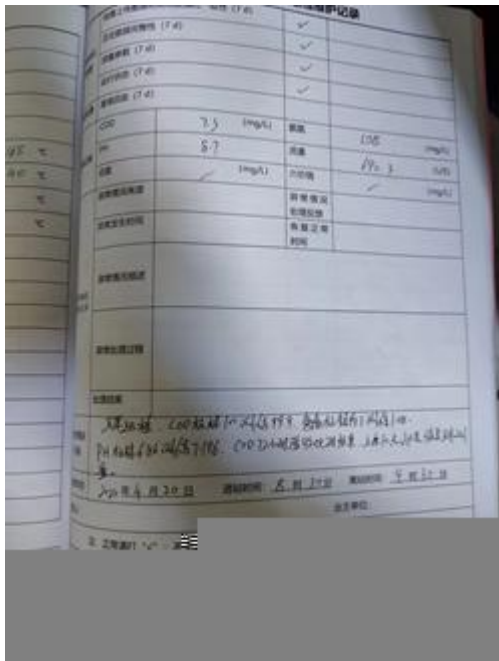
四、能控北 4#排涝泵站

2022 4 18 -4 20 4#
 (CODcr) 18 76.10 mg/L 19 142.57
 mg/L 20 71.06 mg/L COD
 72 COD

编辑常规监测因子标记记录

*污染源： 马鞍山钢铁股份有限公司

*标记类型： 调试

*开始时间： 2022-04-17 15:00:00

*监测因子： pH 化学需氧量 氨氮 流量

*备注： 厂家调试

*监控点： 能控北4#排涝泵站

*子类型： 自动监测设备新装调试

结束时间： 2022-04-20 17:00:59

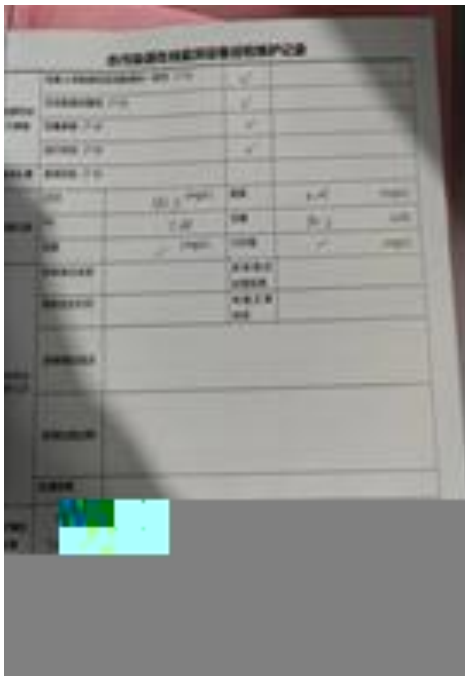
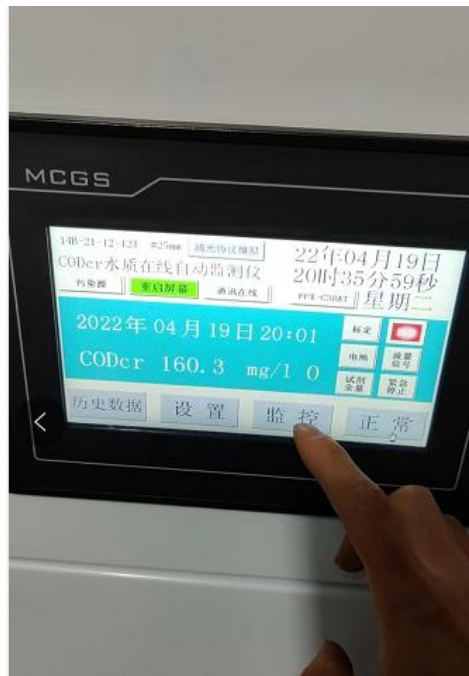
五、冷轧北水处理排口

2022 4 19 -4 20
 (CODcr) 19 70.982 mg/L 20 148.195
 mg/L COD 72
 COD
